## SN & SQ Error Guide

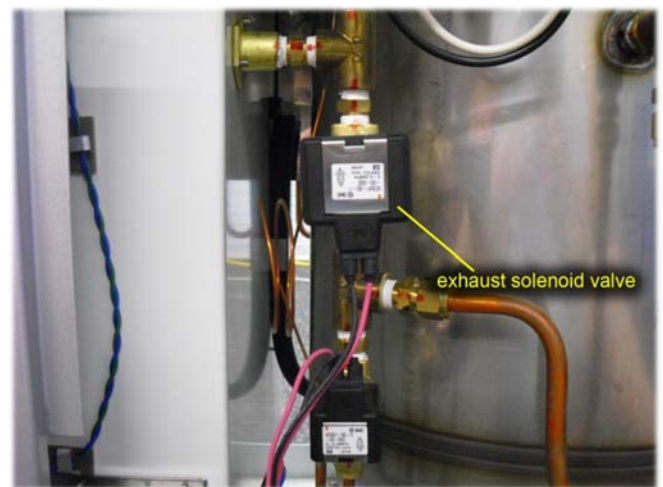
Figure 8

1. To check if the solenoid valve is defective, open the right side panel on the unit.
2. Locate the exhaust solenoid valve (See Figure 8) and its corresponding connector labeled V1 (See Figure 9).
3. Disconnect the V1 connector and check the voltage using a multimeter set to **DC voltage**.
  - a. If there is no voltage, the CPU board is defective and needs to be replaced. Please contact Yamato Scientific customer service at (408) 235-7725.
  - b. If the voltage reads approximately 24 V DC, the CPU board is working properly. Reconnect the V1 connector and listen for the solenoid valve to move into place. An audible click should be heard. If there is no sound, the solenoid is defective and needs to be replaced. Please contact Yamato Scientific customer service at (408) 235-7725.

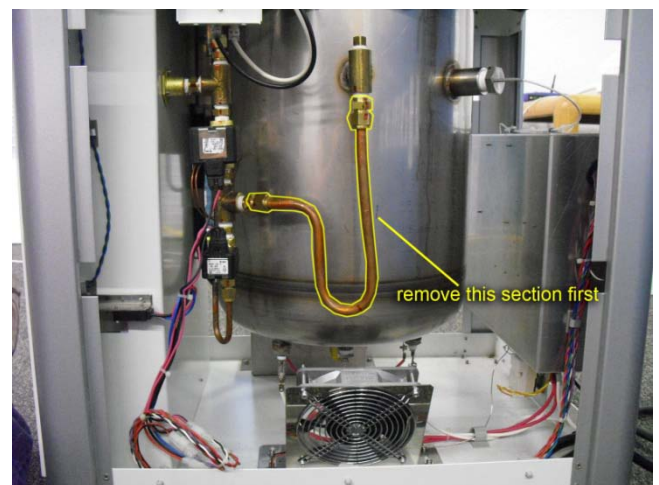
2. Using a wrench, remove the section of the pipe assembly highlighted in Figure 12.
3. Clean the section using compressed air and by flushing it out with clean water. Set the pipe aside.

6. Pull the housing coils off the solenoid assemblies. (See Figure 15)
7. Remove the solenoid valves using a wrench.
8. Clean the solenoids and ensure that the springs are functional. (See Figure 16)
9. Set the solenoids aside and clean the pipe section.
10. Open the front cabinet and remove the rubber tube that connects to the pipe.  
Clean the pipe section.
11. Reassemble the pipes. Use Figure 12 as a reference.
